**Subsidence Documentation Study**  
**Sufco Mine**  
**May 30, 2003**  
**Summary**

The data contained in this binder is a compilation of subsidence features gathered in the field from the 19 of May to the 22 of May 2003. The features have been organized into five different sections representing panels in descending order starting with the most recent. At the beginning of each section is a summary sheet outlining important aspects of the panel with emphasis on subsidence features contained therein.

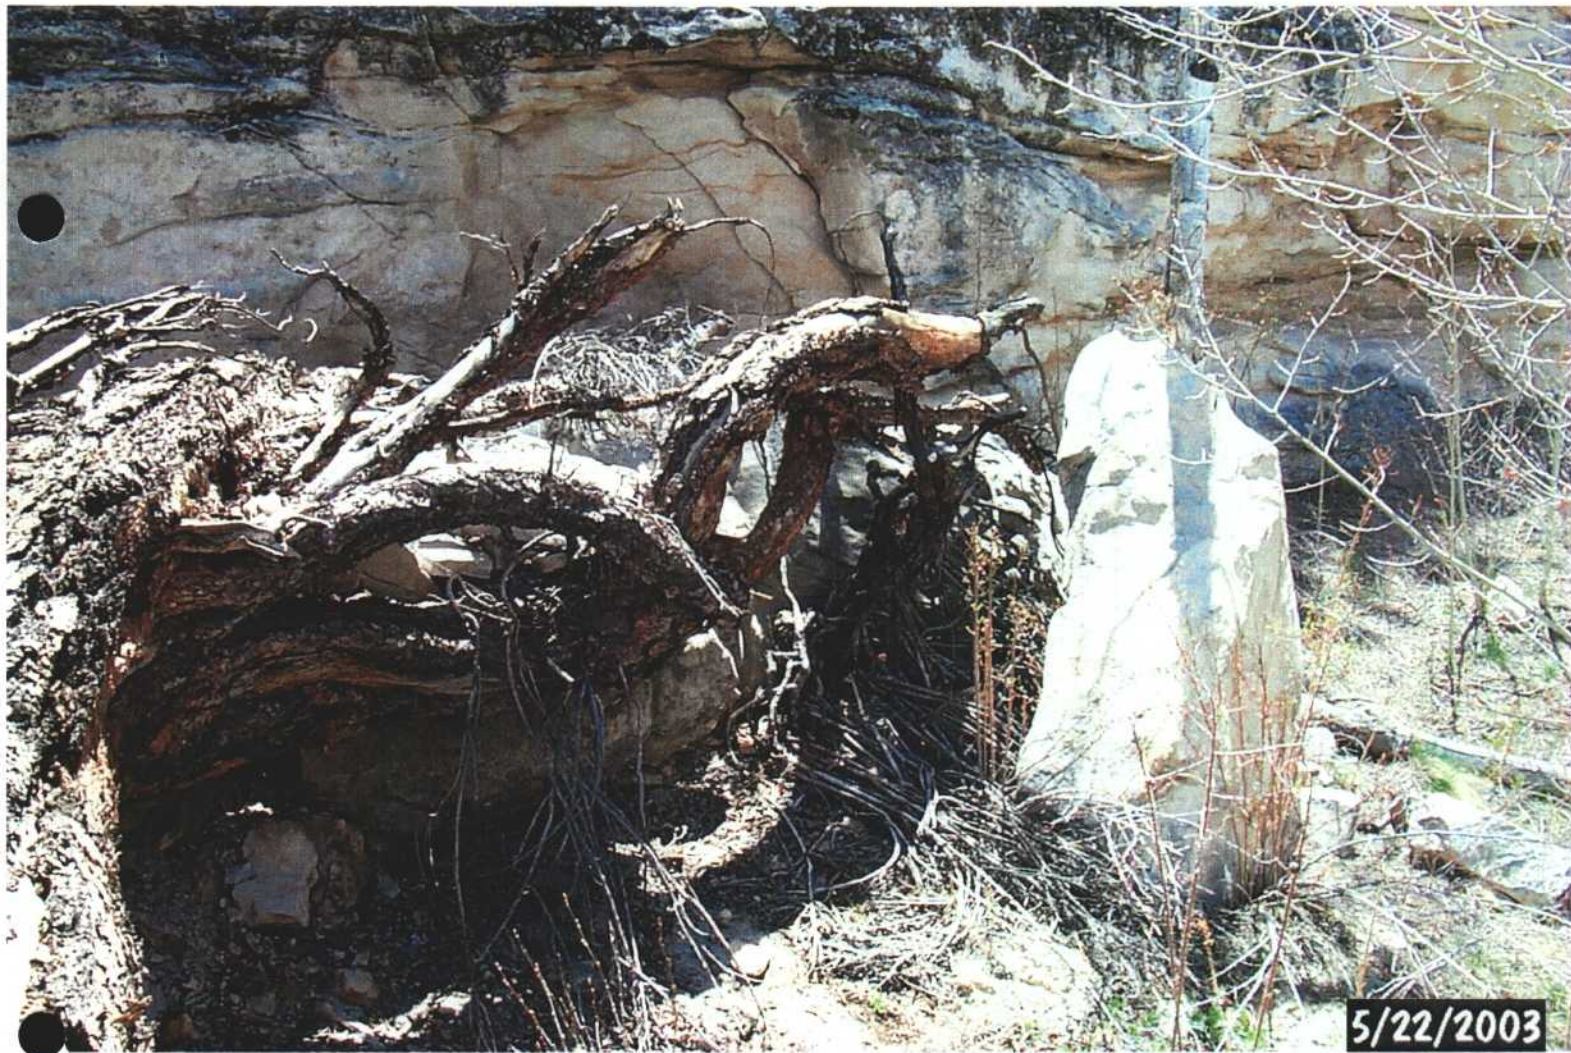
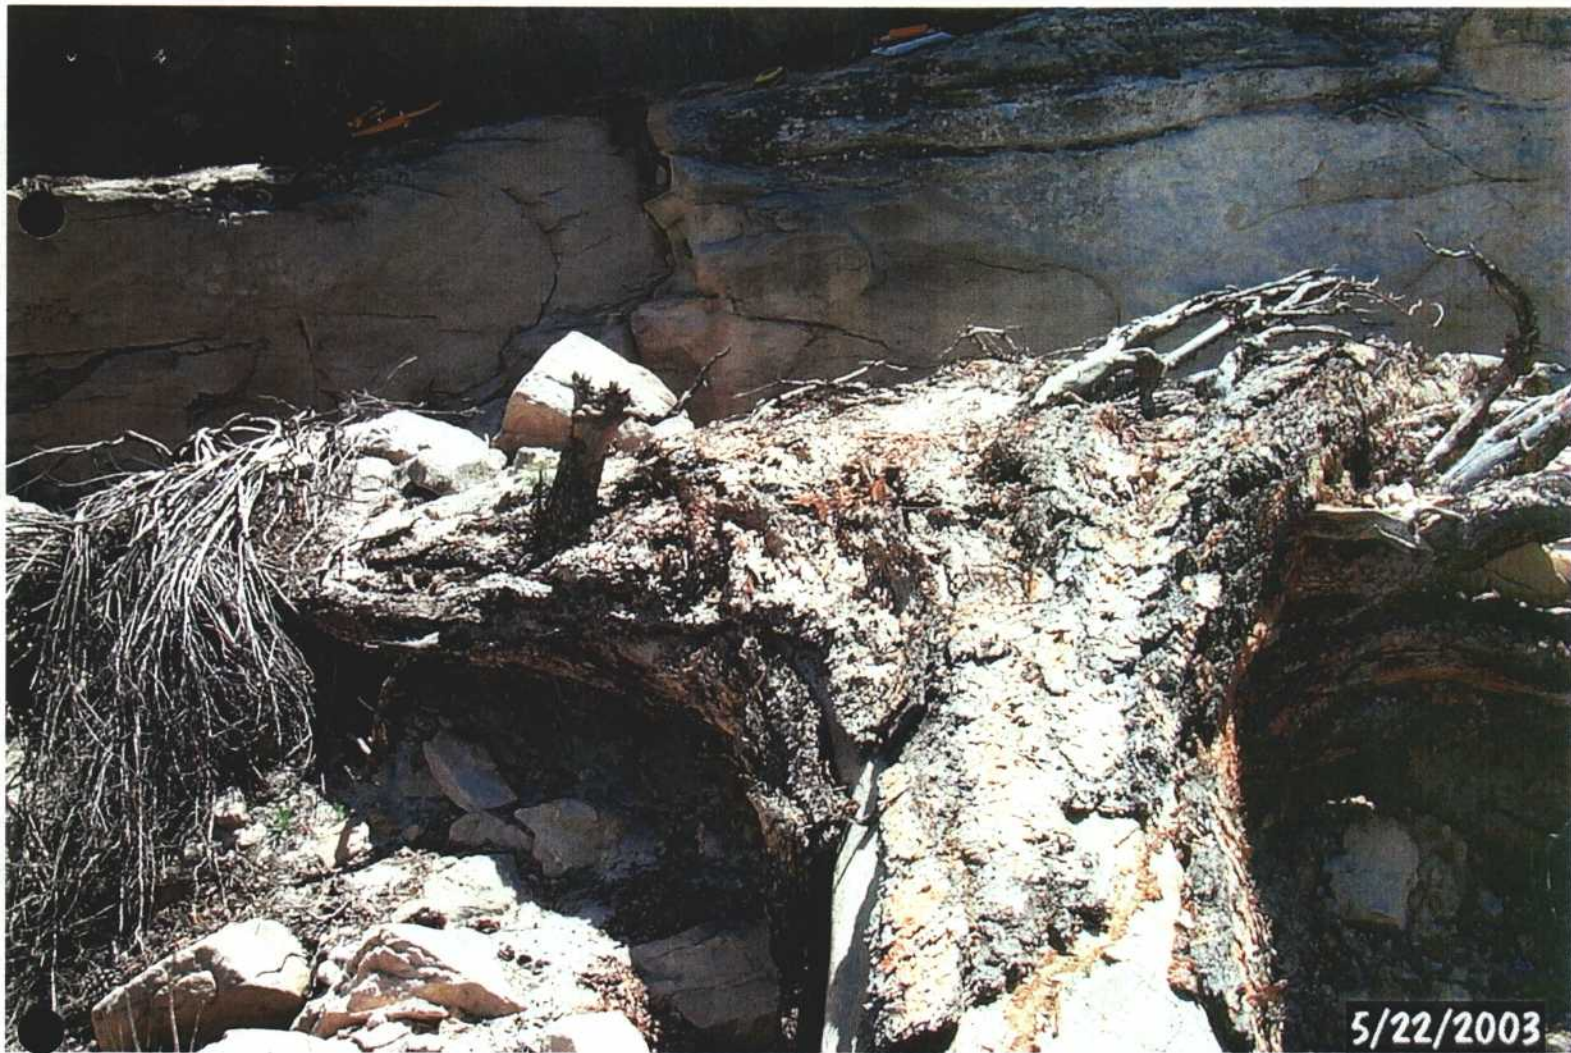
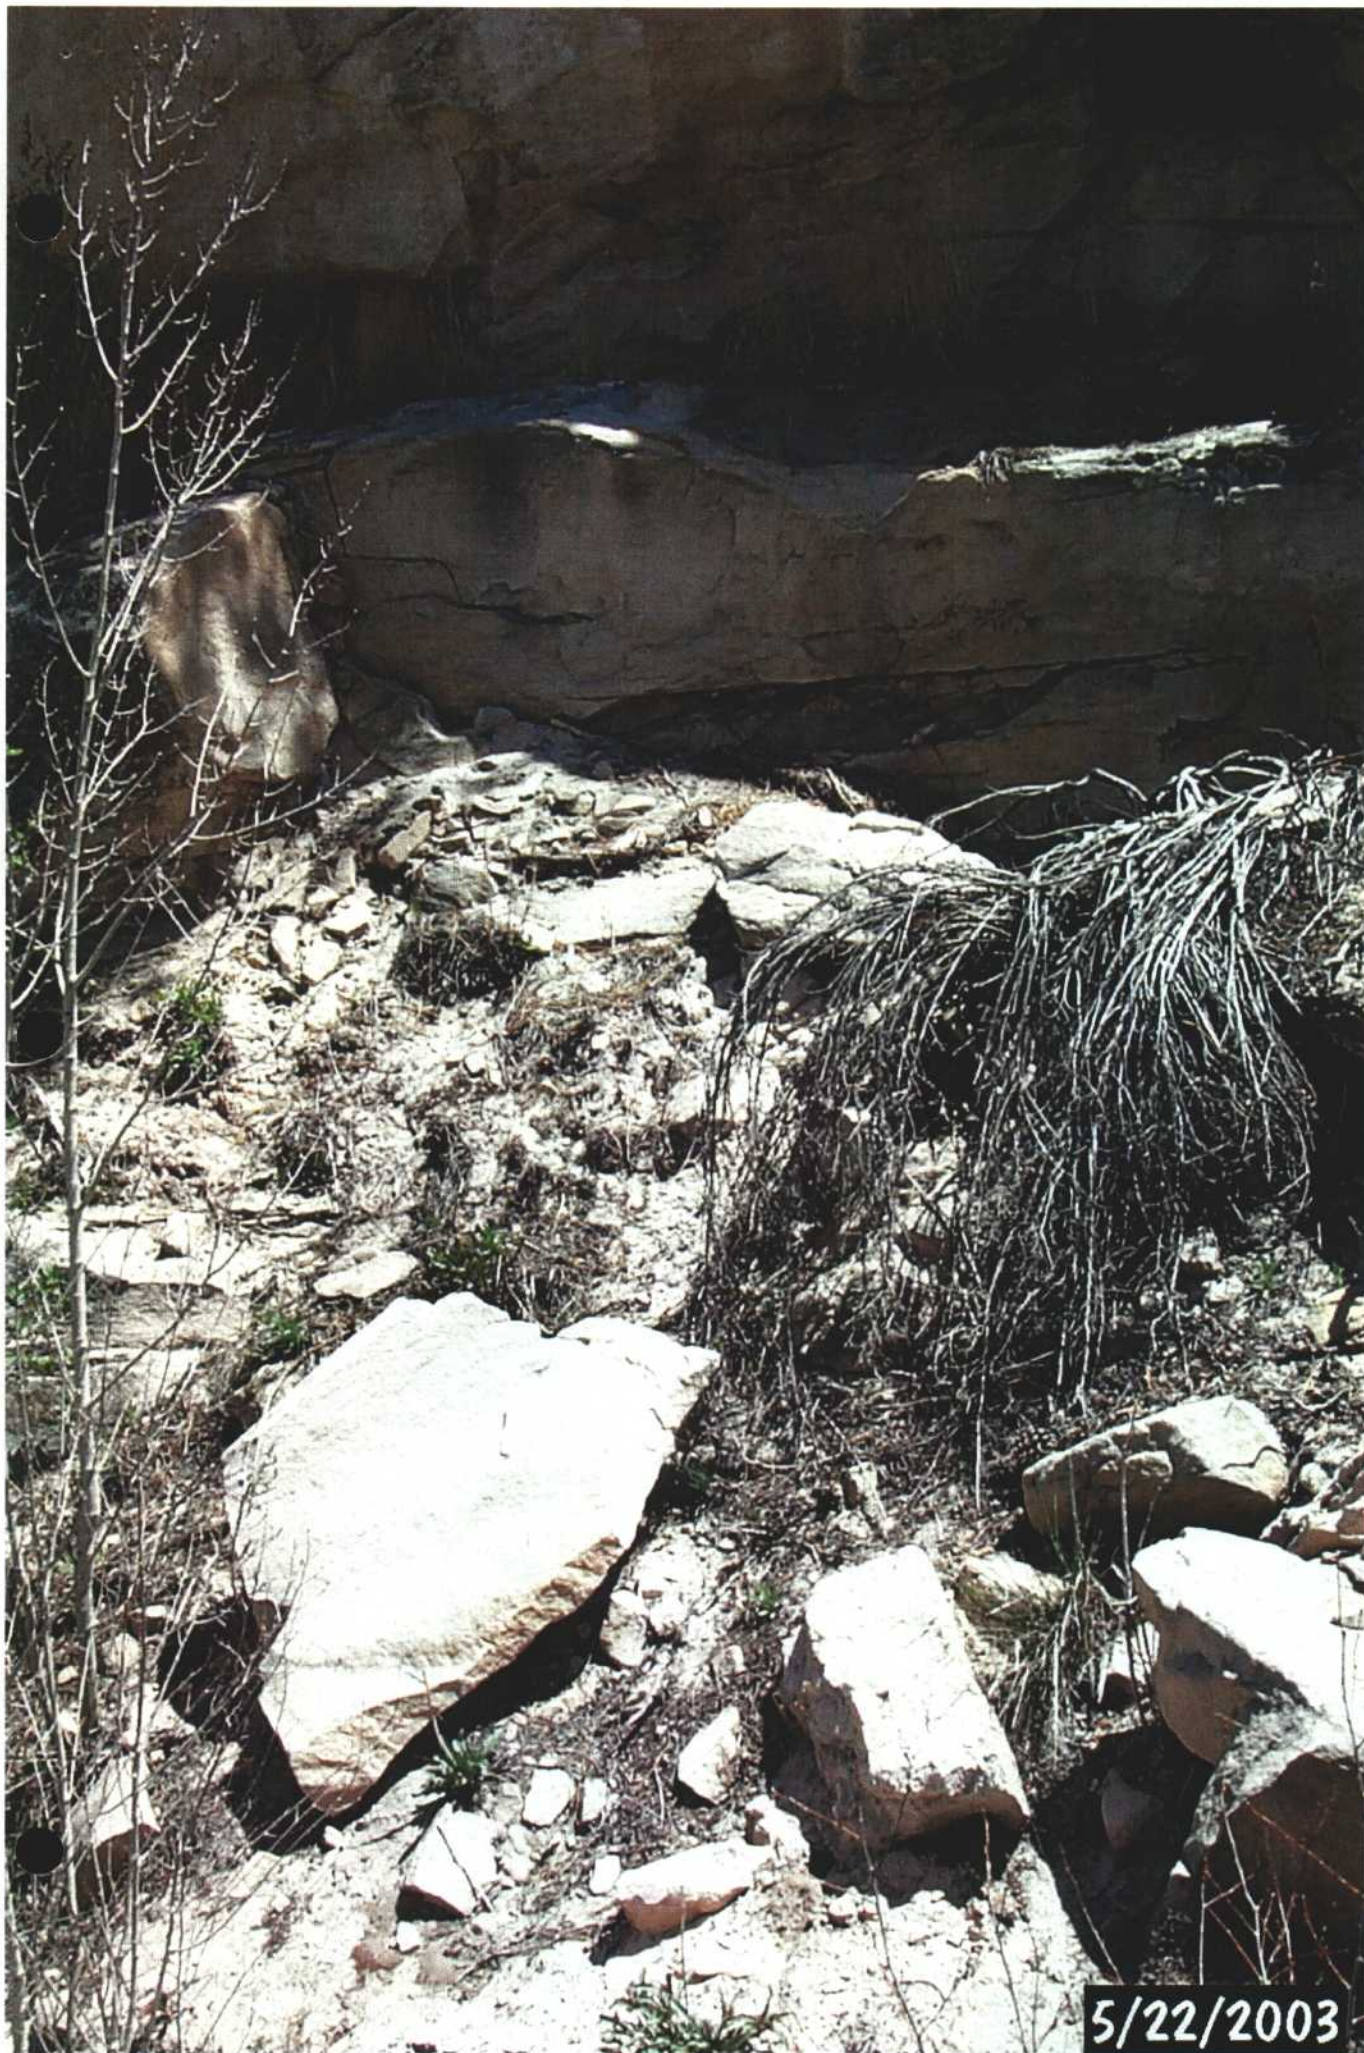
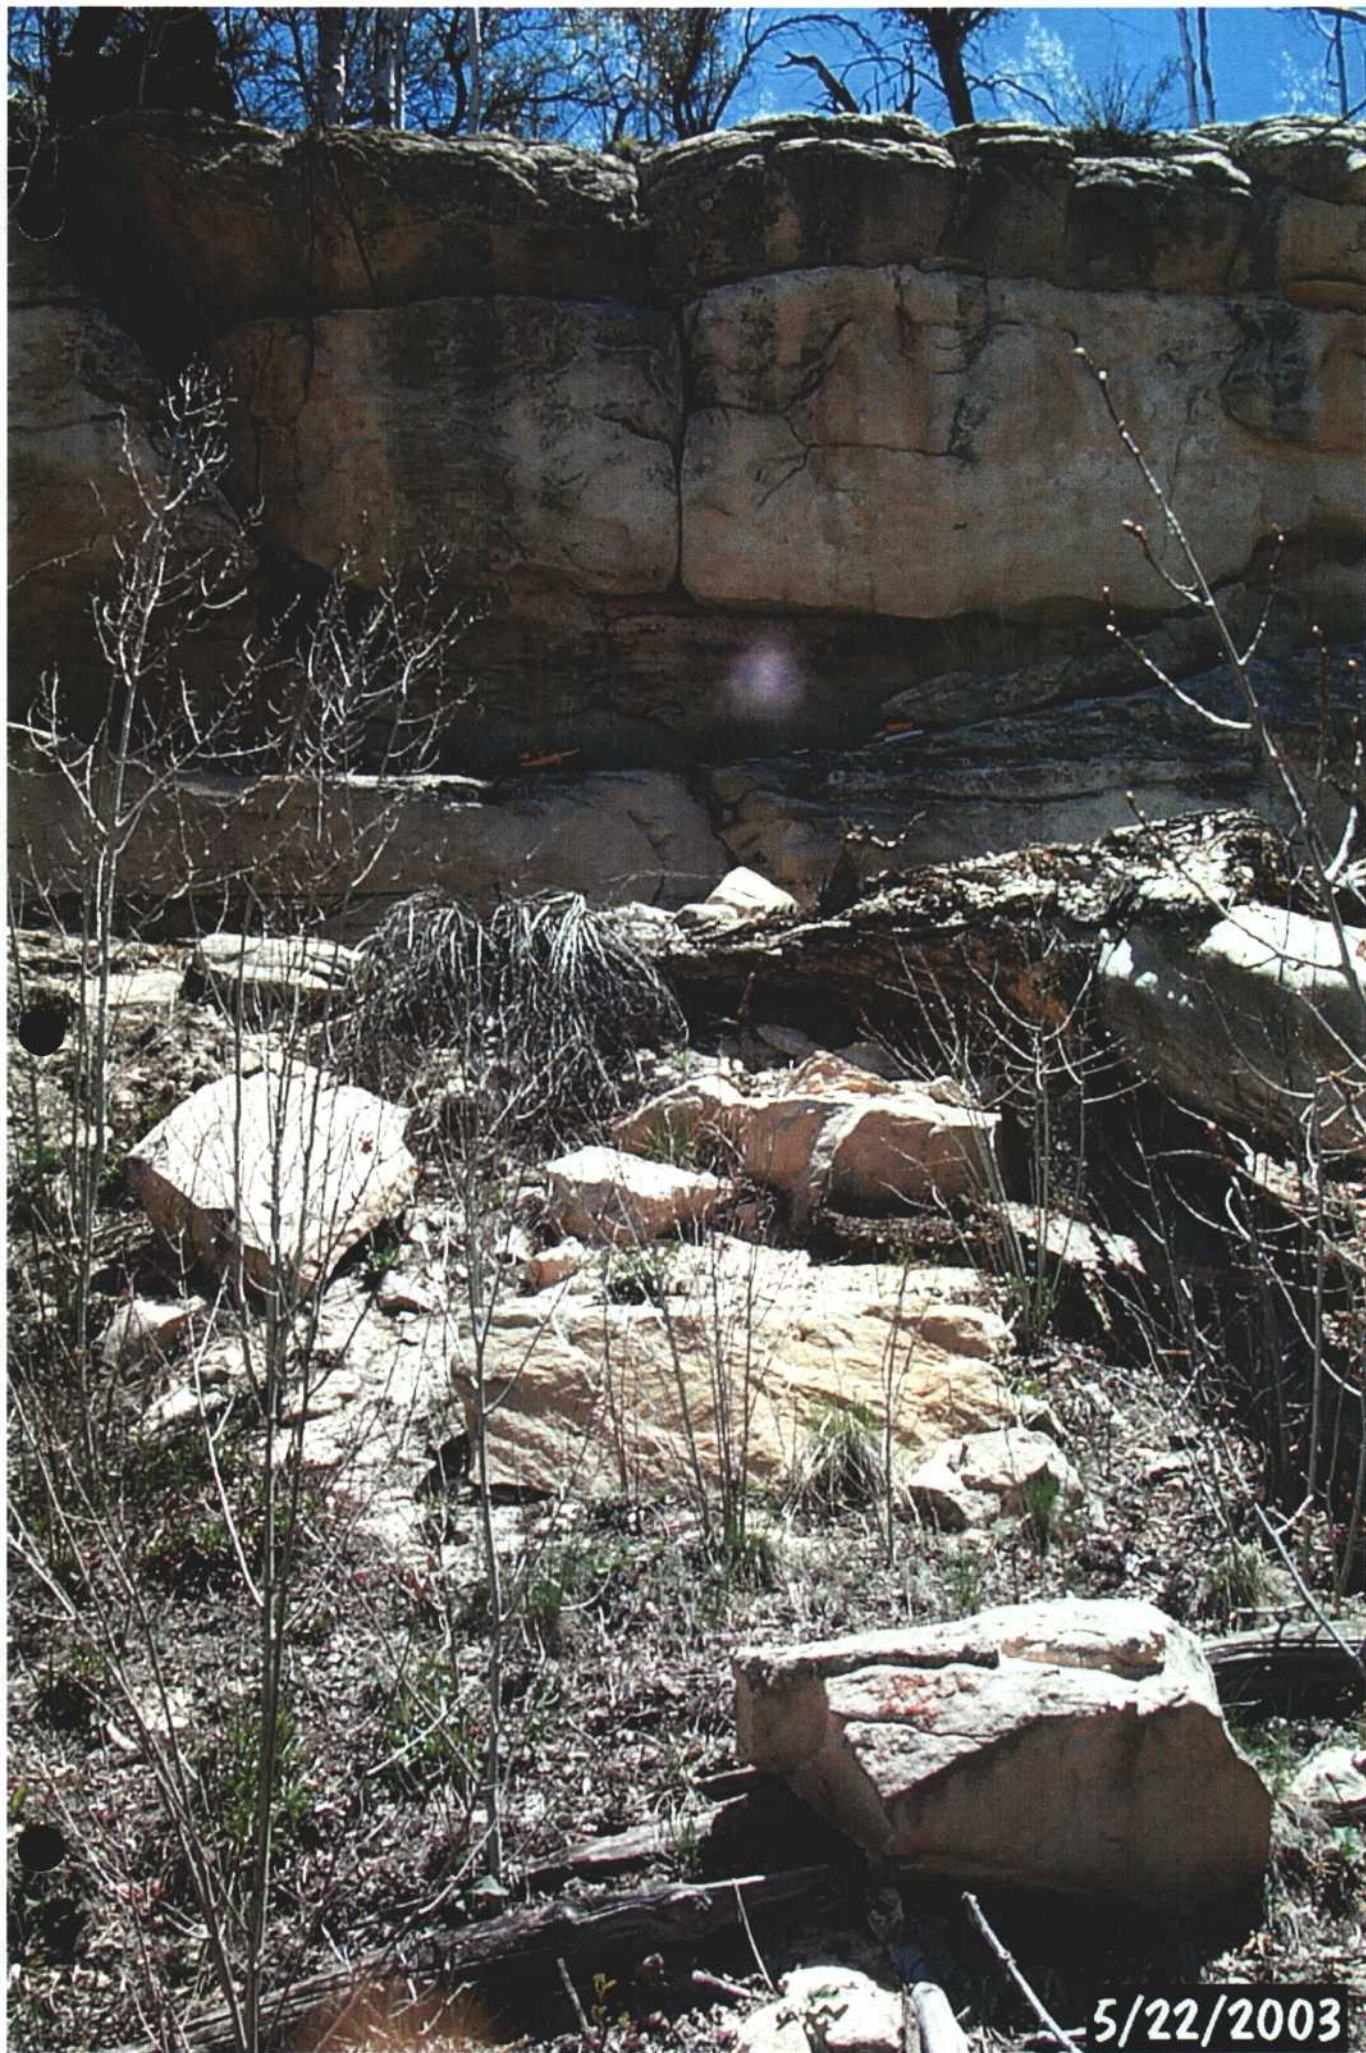
Dimensions (in feet): This is a fifty foot section of cliff spalling.

A large Ponderosa Pine was growing up through cracks in the cliff face.  
When spalling occurred, the rocks supporting the tree's roots broke loose, and the tree fell.

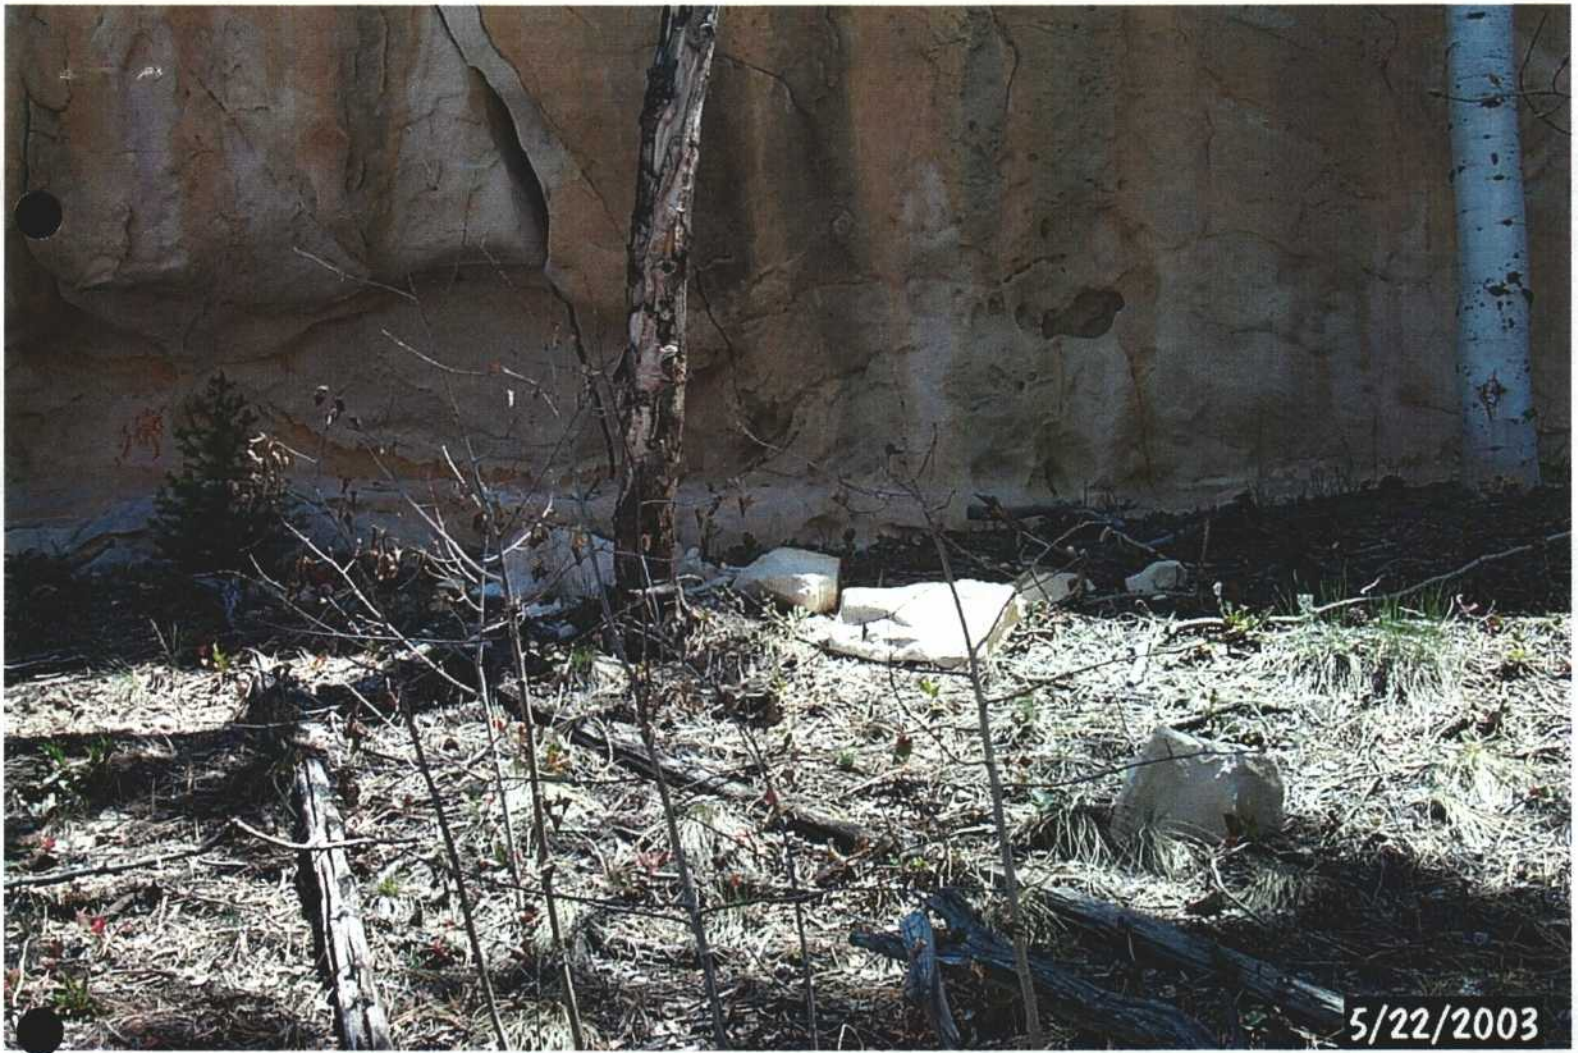
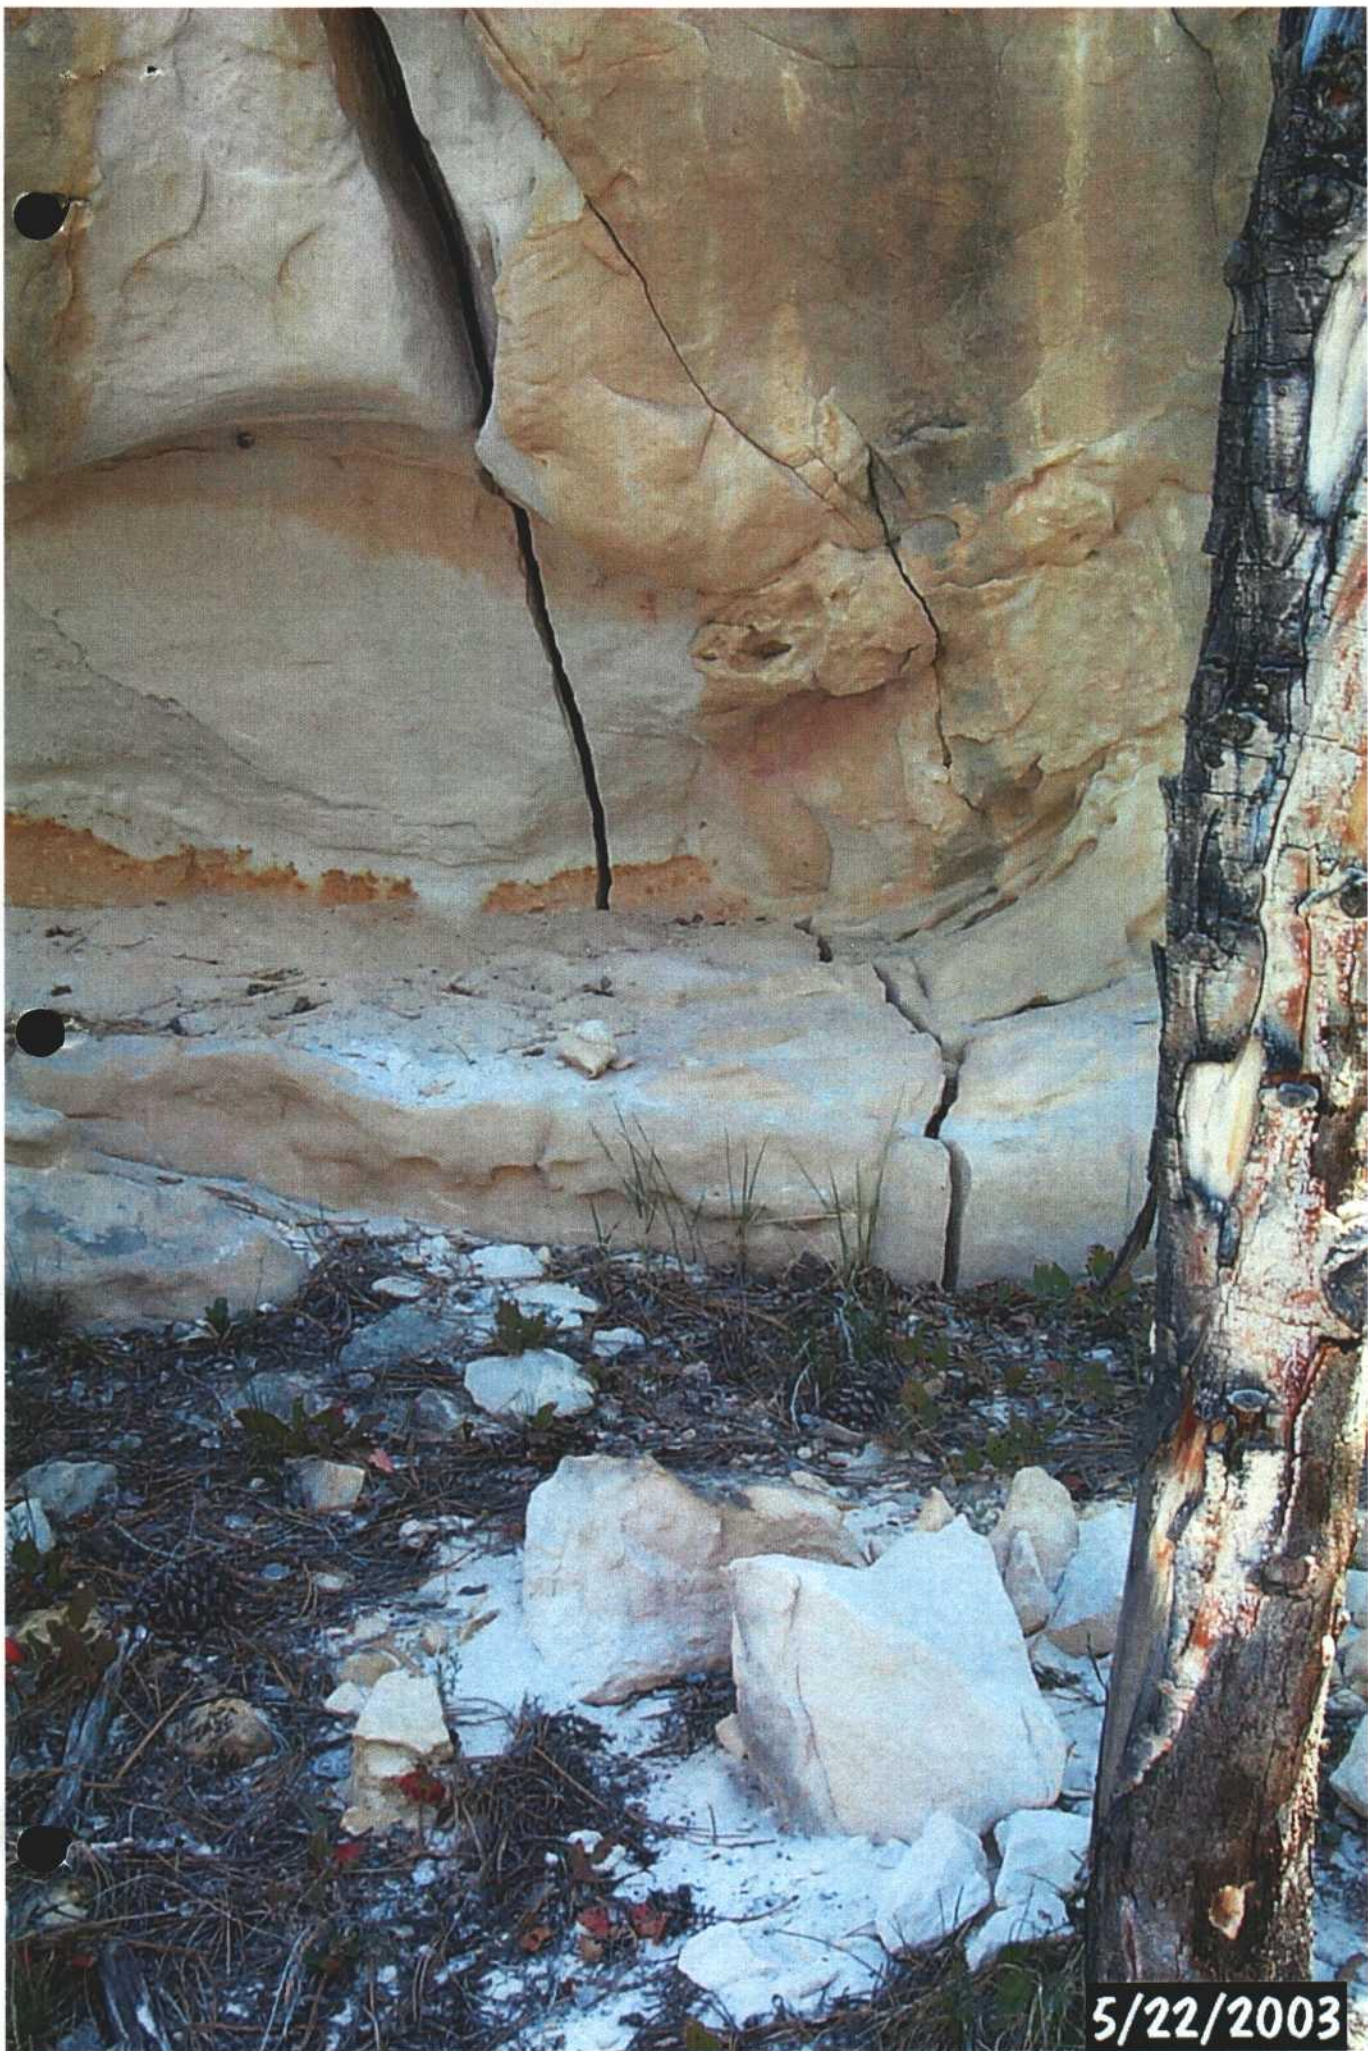
Dimensions (in feet): Approximately an eighty foot crack in the cliff face, with  
minor spalling.

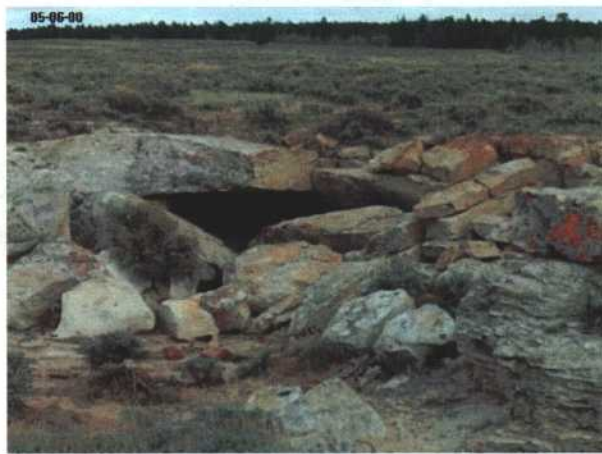
Figure 1 Before-May 6, 2000

This site was undermined on 3/26/02. This cultural site had numerous natural rock failures before it was undermined (Fig. 1 & 3). Subsidence impacts were about what was anticipated when the monitoring program was initially set up. Subsidence impact resulted in the overhanging rock on the right side, that already had a large crack on the backside, breaking loose and falling in. The overhanging rock on the left side rolled into the opening (Fig. 2 & 4). The overhang on the left side could have already been cracked similar to the right side since it broke across on the same crack line. How much the site has subsided is not know yet. The subsidence will be measured over the next few weeks.

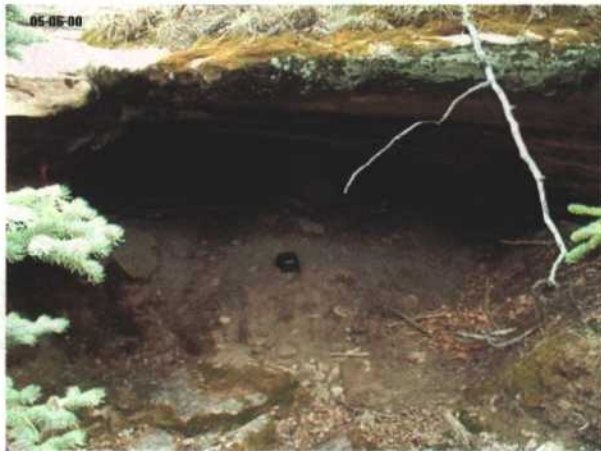
Figure 5 Before-May 6, 2000

This site was undermined on 3/22/02. Subsidence impacts were not what was anticipated when the monitoring program was initially set up. The overhanging rock had some natural small cracks but was not broken up as much as some of the other sites and it was felt that this site would probably not be impacted by subsidence (Fig. 5 & 7). Subsidence impact resulted in the roof rock cracking in the center of the site and breaking off on the right side (Fig. 6 & 8). This is similar to what happen at the 42SV2492 150-Acre site in 2000 but not as severe. This site has not been surveyed since it subsided to determine how much the site has subsided.
